PROPERTY INSPECTION REPORT

Concerning: 1305 FM 359. Suite E Richmond, TX
(Address or Other Identification of Inspected Property)

By: Ray Hinsley TREC #6387 5/15/2014
(Name and License Number of Inspector) (Date)

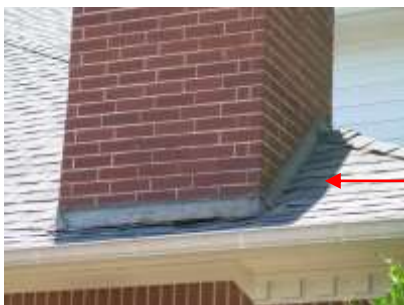
The counter flashing is not installed properly as it does not overlap sufficiently to ensure protection against moisture intrusion. It should be repaired around fireplace at left side of home.

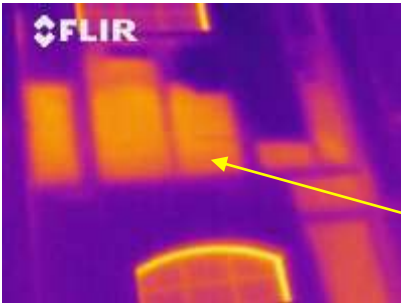
*Observed missing insulation on front wall of entry area. Insulation should be blown in to protect from thermal loss.

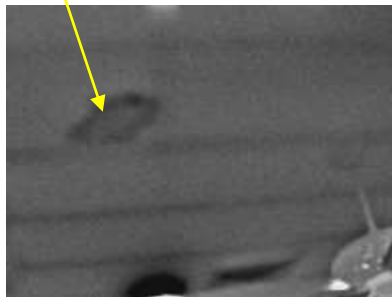
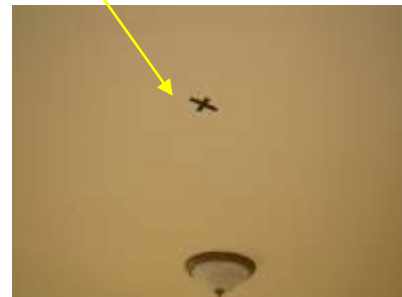
Moisture was detected at left rear bedroom ceiling (40% moisture level in sheetrock), recommend repair. Moisture is originating from A/C refrigerant line condensation in attic. Repairs should be undertaken to prevent further damage.

Moisture with infrared

Unable to see moisture with naked eye

Both A/C refrigerant lines in attic should be properly insulated to avoid condensation/water damage (see ceiling section notes above).

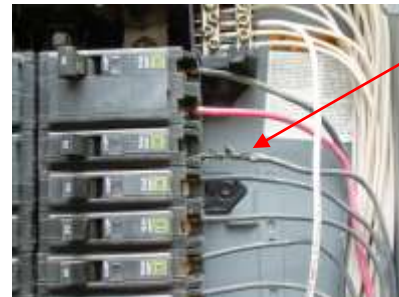
Overheated wiring and or breakers within the main distribution panel should be examined by a licensed electrician and repaired promptly as this is a safety issue.

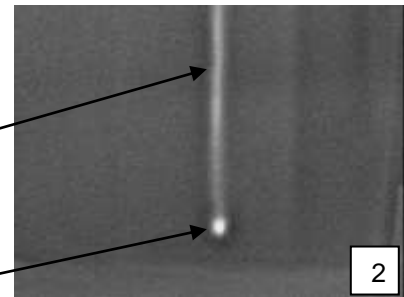
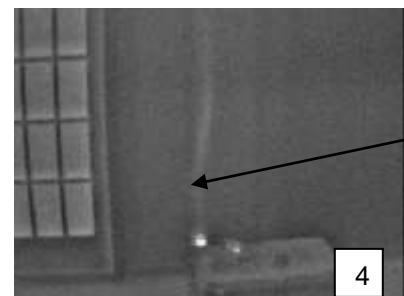
*An outlet and wiring appear to have overheated at left rear bedroom switch and outlet near door (1), upper right bedroom rear wall outlet (2), front den light switch (3) and living room rear wall right outlet (4). These switch and outlet circuits should be repaired by a licensed electrician.

Infrared of hot wires in wall
