PROPERTY INSPECTION REPORT

Concerning: 1305 FM 359. Suite E Richmond, TX
(Address or Other Identification of Inspected Property)

By: Ray Hinsley TREC #6387 5/15/2014
(Name and License Number of Inspector) (Date)

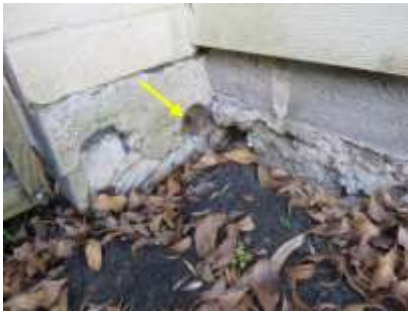
In my opinion the foundation is performing as intended.
 Exposed post tension cable ends were observed on the exterior of the foundation. They should be sealed/repared to prevent corrosion.

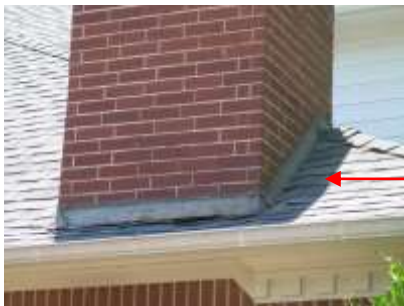
The counter flashing is not installed properly as it does not overlap sufficiently to ensure protection against moisture intrusion. It should be repaired around fireplace at left side of home.

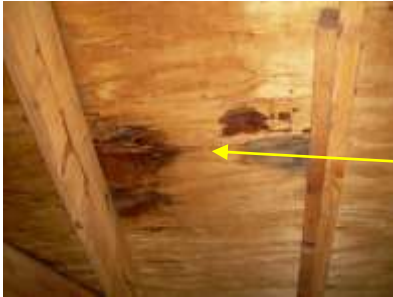
*Evidence of roof leakage was observed on roof decking in attic. This area is below the chimney flashing (refer to above roof covering section) repairs should be made as necessary.

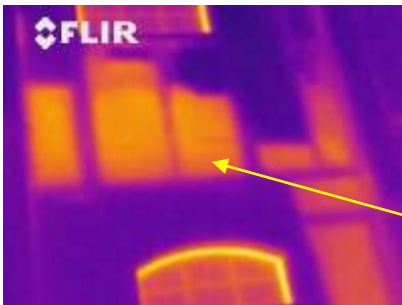
*Observed missing insulation on front wall of entry area. Insulation should be blown in to protect from thermal loss.

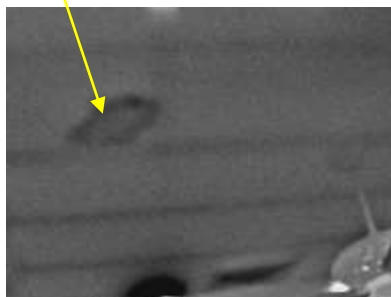
Moisture was detected at left rear bedroom ceiling (40% moisture level in sheetrock), recommend repair. Moisture is originating from A/C refrigerant line condensation in attic. Repairs should be undertaken to prevent further damage.

Moisture with infrared

Both A/C refrigerant lines in attic should be properly insulated to avoid condensation/water damage (see ceiling section notes above).

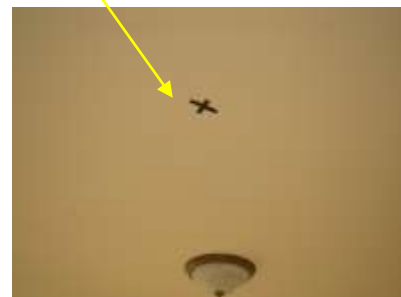
Unable to see moisture with naked eye

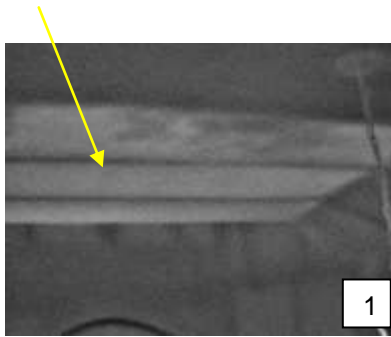
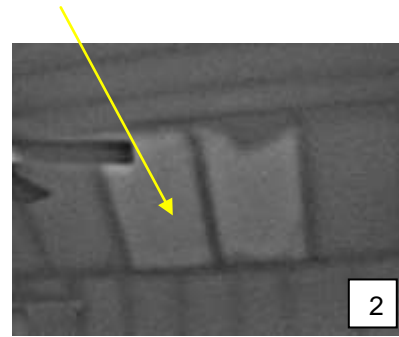
Observed missing or compressed insulation at entry foyer ceiling above door (1) and living room right ceiling (2), insulation should be blown in to protect from thermal loss.

Missing insulation with infrared

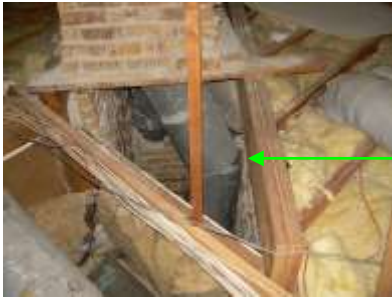
It is recommended that a damper stop (c-clamp) be added to the flue damper allow gas to escape in case of leak.

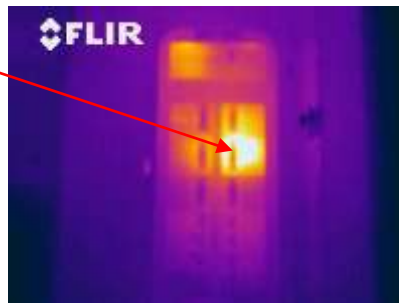
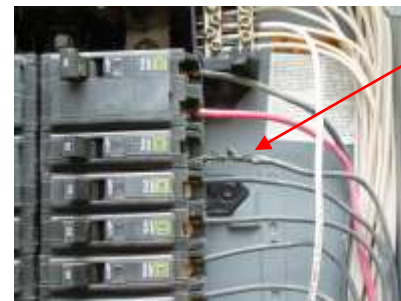
Overheated wiring and or breakers within the main distribution panel should be examined by a licensed electrician and repaired promptly as this is a safety issue.
